MDDS - Monument Damage Diagnostic System

Balen K. Van, Mateus J., Binda, L., Baronio, Hees R.P.J. van, Naldini S., Klugt L.van der, Franke L., Expert System for the evaluation of the deterioration of ancient brick structures, EU Environment Program, EV5V-CT92-0108, Research report No. 8, 1999. The system was restructured within the project 'Compatibility of plasters and renders with salt loaded substrates in historic buildings' (EVK-CT 2001-00047).

Caratteristiche del sistema esperto.

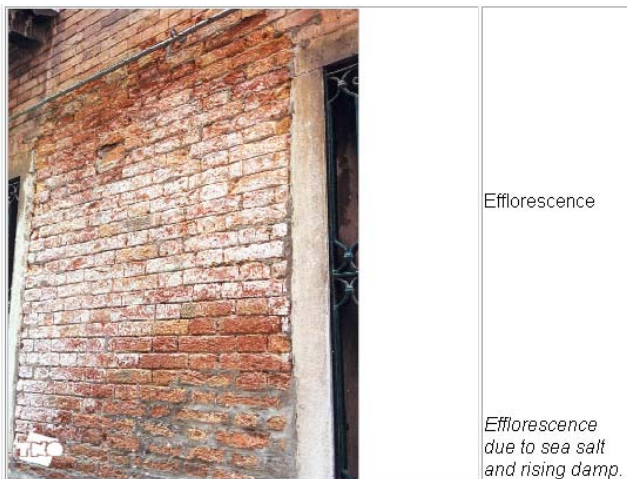
mattoni

• Articolata sezione fenomenologica e descrittiva degli effetti dei fenomeni di degrado riguardante:

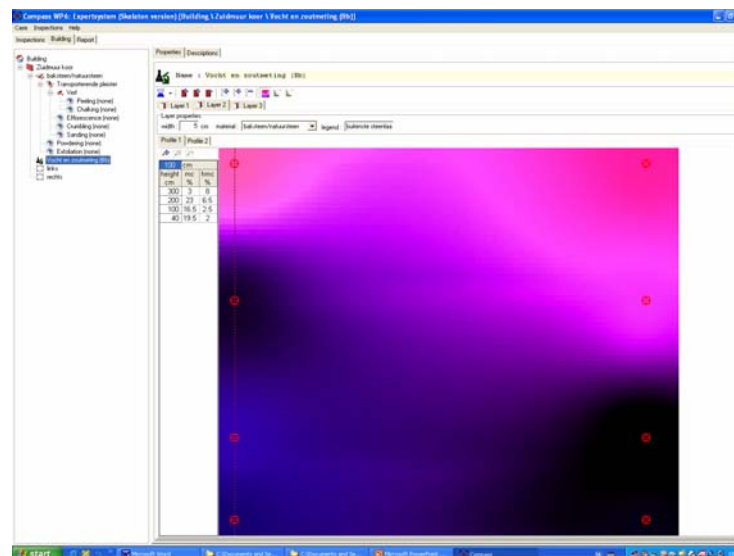
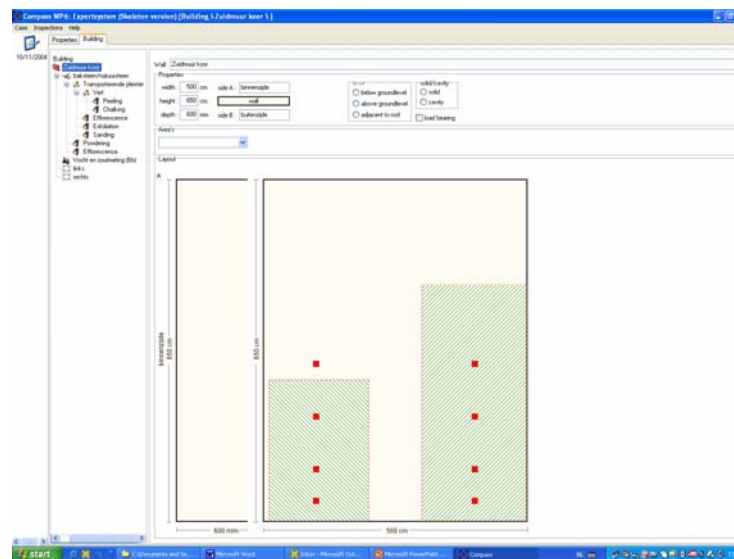
- tecniche di misura sali e umidità nella muratura

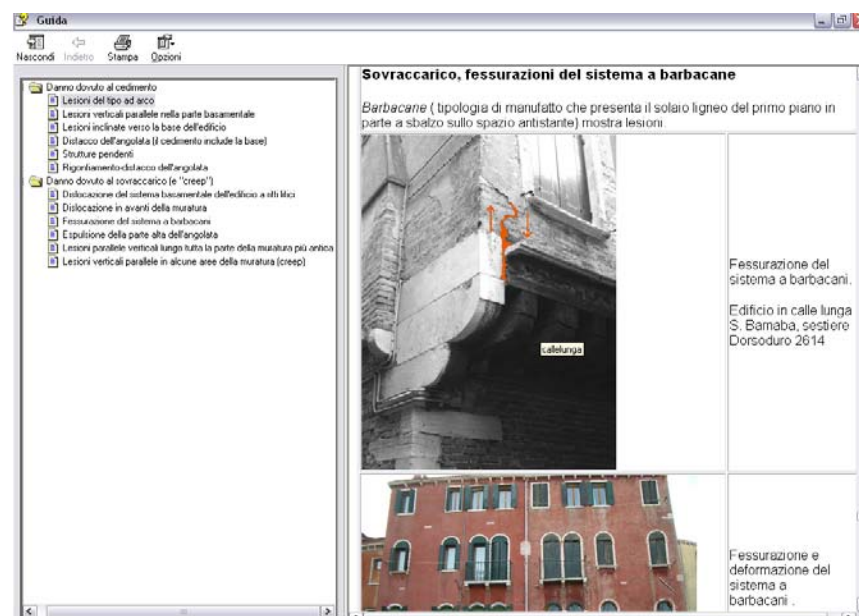
- Presenza di molteplici fasi costruttive
- Presenza di elementi di contrasto di dissesto progressivo
- Realizzazione abaco preliminare dei fenomeni indicizzato (formato .html; versine ita-eng)

Fenomenologia di lesioni e deformazioni
